# Manhole Inspection Summary

Manhole # S23W\_\_021MH

Insp Date: **2/10/09 2:23 PM**

**Location** Address: **Ontario Ave.**

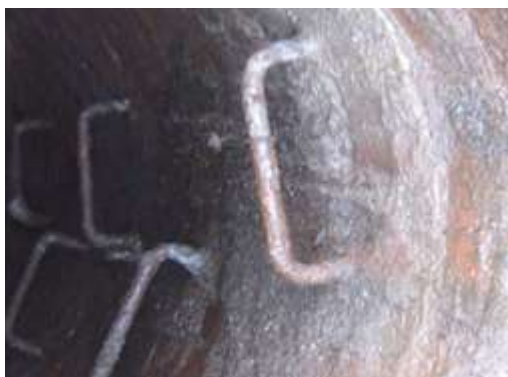
Defect 4

chimney infiltration at frame joint and mortar, corbel infiltration at chimney joint

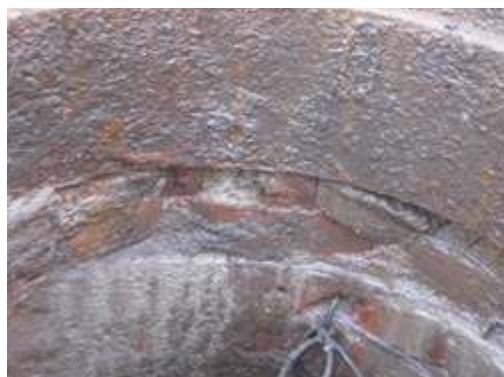
Defect 5

frame infiltration at cover, chimney deteriorated, chimney infiltration at frame joint

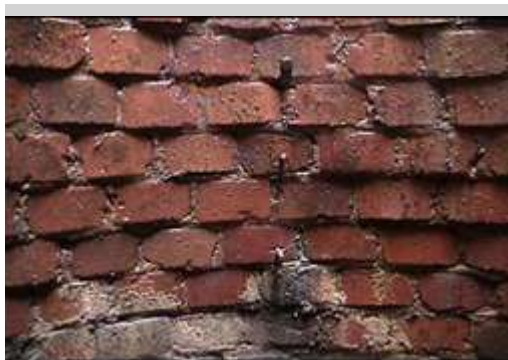
Defect 3

corbel infiltration at mortar and wall

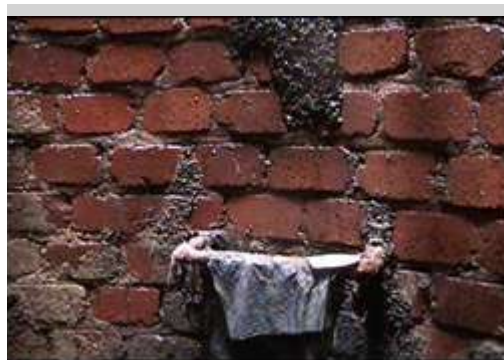
Defect 2

surcharge evidence 3.5 feet, steps corroded

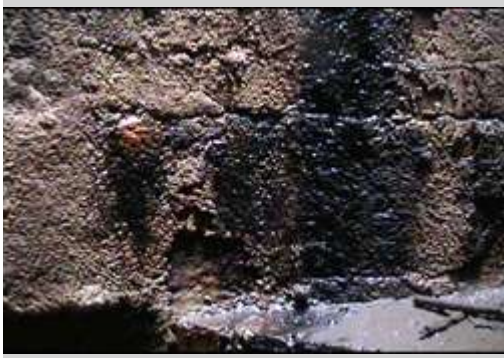
### Defect 1

barrel infiltration at mortar

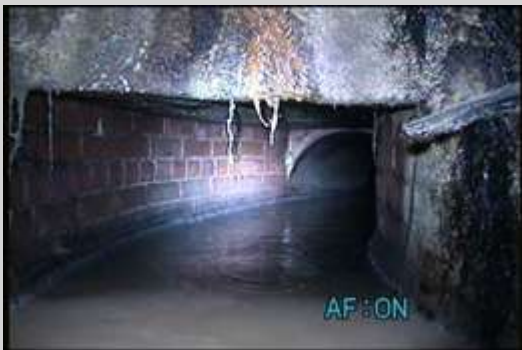
12 O'Clock Outflow

Pipe Height: **22.8** (in.) Rod and Bar (Angled)  
Pipe Material: **Clay** ☐ Pipe Lined  
Invert Depth: **12.22** (ft.) Flow Characteristics: **Fast**  
Deposits: ☒ None ☐ Mud ☐ Sludge ☐ Debris ☐ Grease  
Silt Depth: **0** (in.) Deposits Extent:  
Infiltration: **None** Pipe Seal Cond: **Sound**

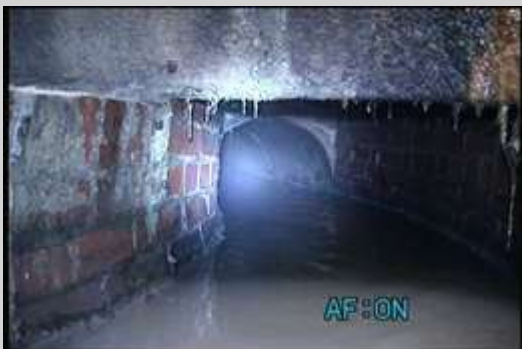
5 O'Clock Inflow

Pipe Height: **22.8** (in.) Rod and Bar (Angled)  
Pipe Material: **Clay** ☐ Pipe Lined  
Invert Depth: **12.28** (ft.) Flow Characteristics: **Fast**  
Deposits: ☒ None ☐ Mud ☐ Sludge ☐ Debris ☐ Grease  
Silt Depth: **0** (in.) Deposits Extent:  
Infiltration: **None** Pipe Seal Cond: **Sound**
